St. MARY'S CHURCH, MALTON
(formerly Malton Priory)
North Door, west face

Mortars and condition

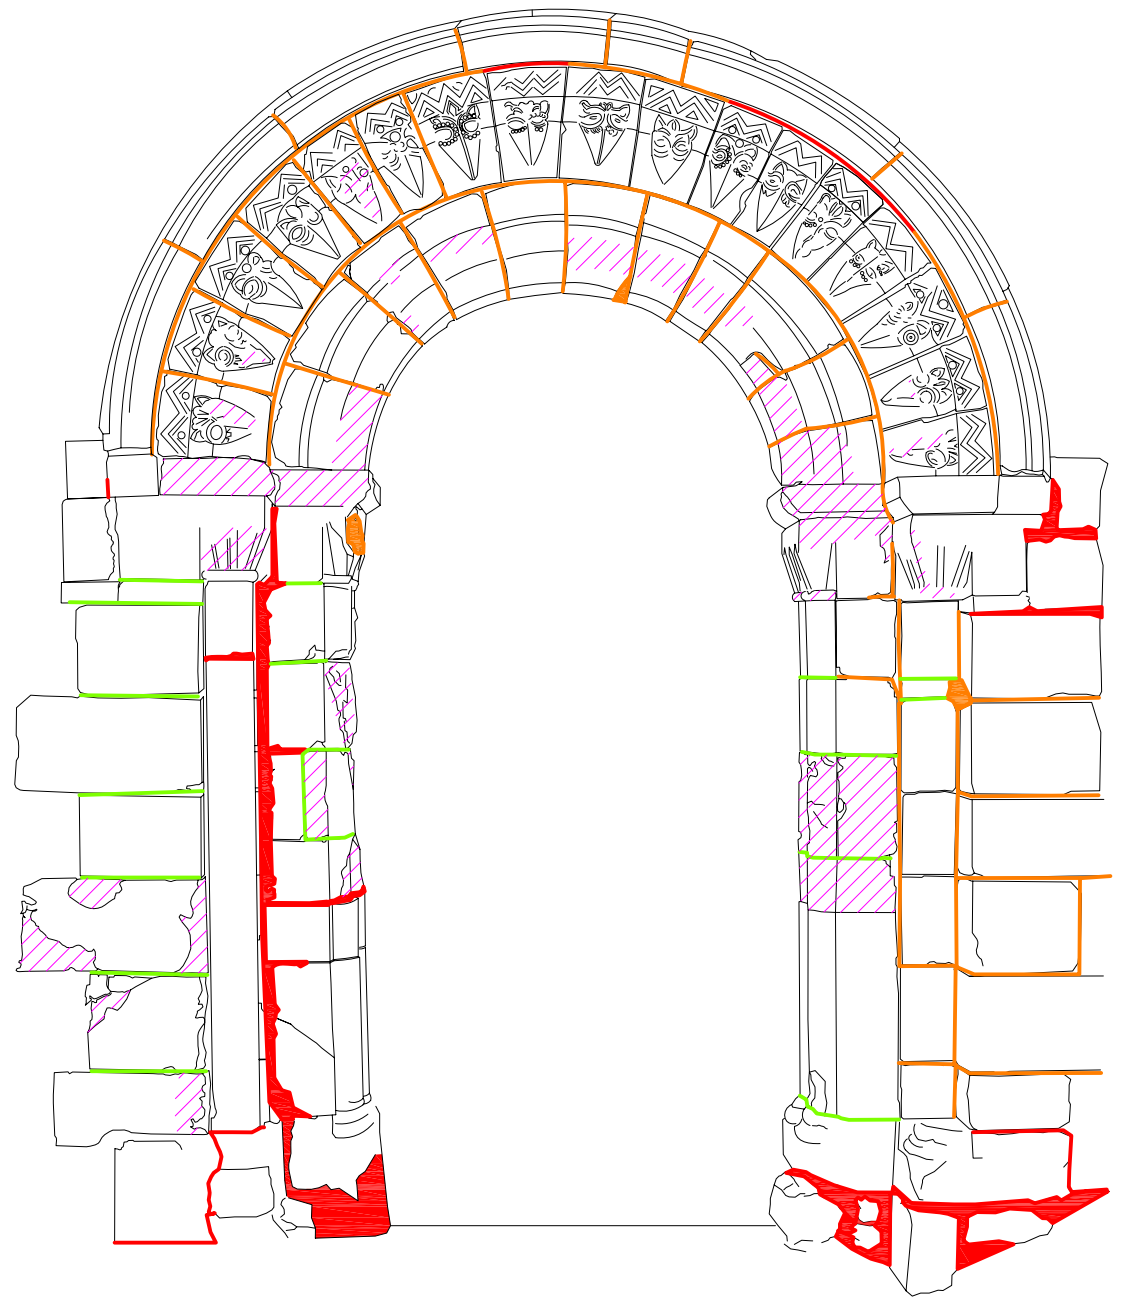
Ordinary Portland Cement

Roman Cement

Lime-based mortar

Salt-related decay
