St. MARY'S CHURCH, MALTON
(formerly Malton Priory)
North Door, west face

Geology

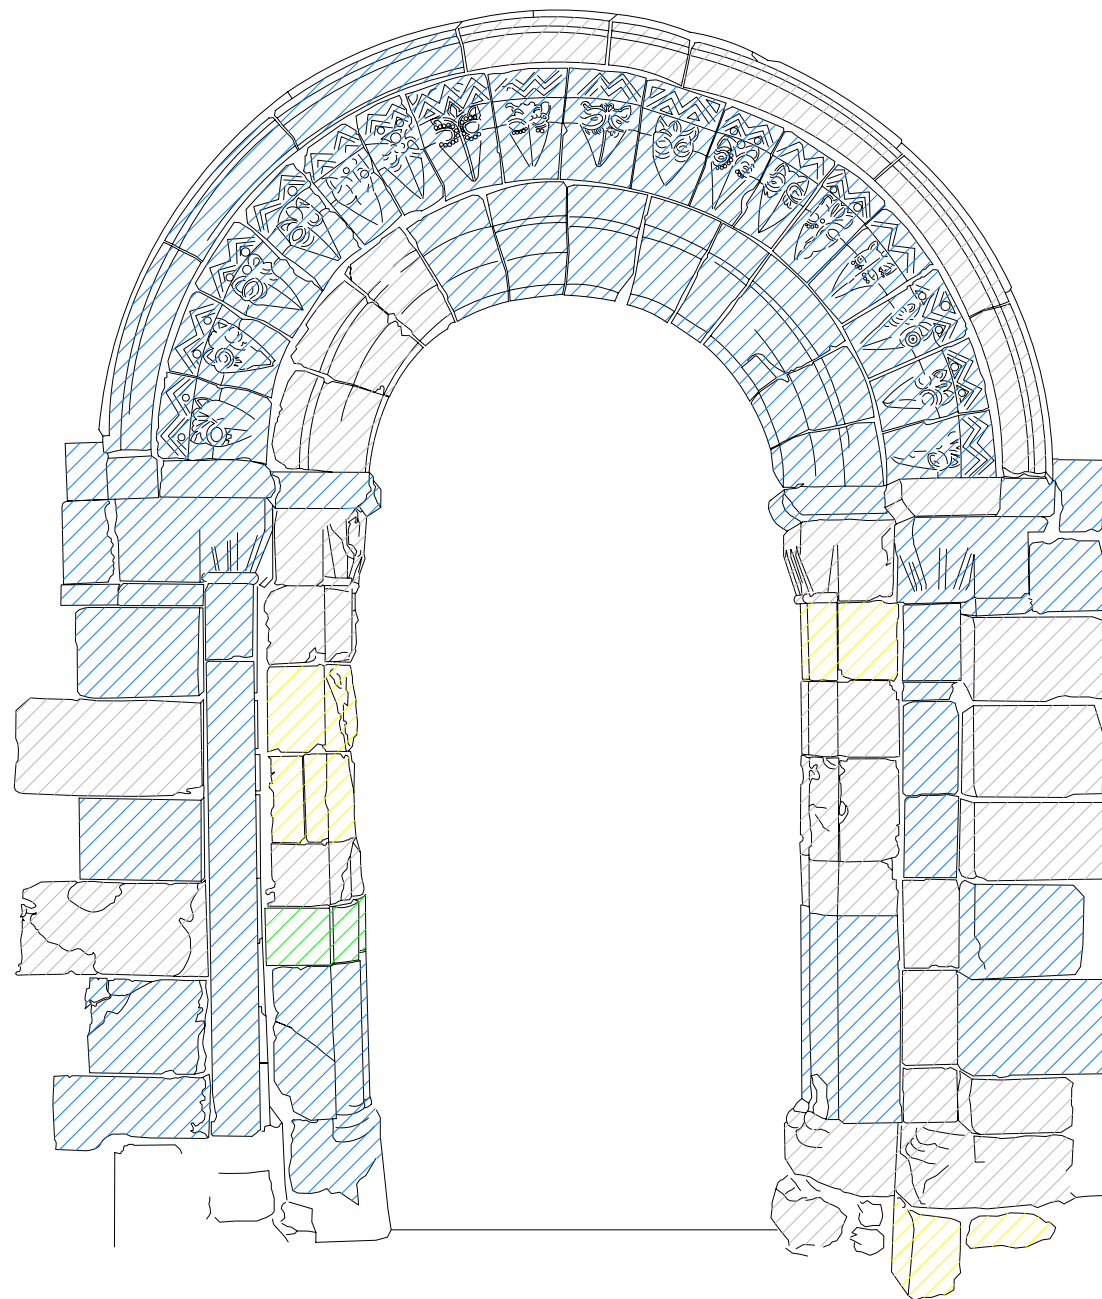
Coarse-grained
Hildenley Limestone

Fine-grained
Hildenley Limestone

Oolitic Limestone

Magnesian
Limestone
